# **INDOOR AIR QUALITY ASSESSMENT**

**Georgetown Senior/Middle School  
11 Winter Street  
Georgetown, Massachusetts**

Prepared by:  
Massachusetts Department of Public Health  
Bureau of Environmental Health Assessment  
March, 2002

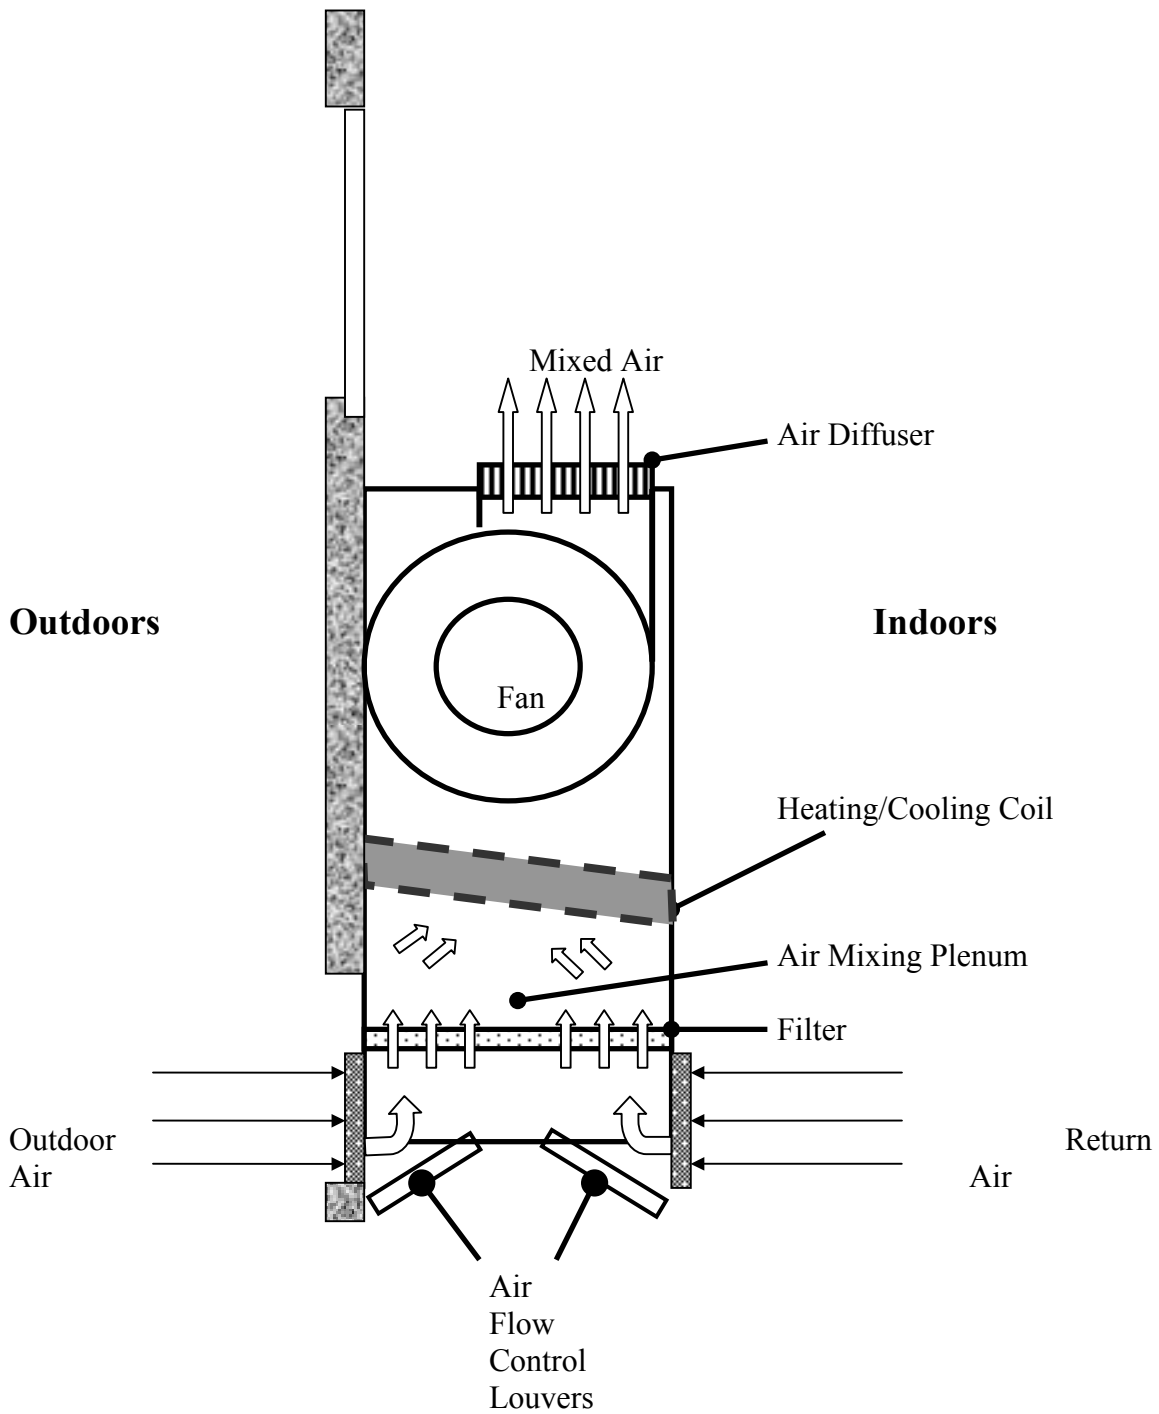
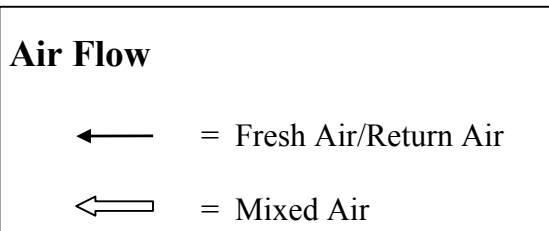
**Figure 1**

Fresh air in classrooms is supplied by a unit ventilator (univent) system (see Picture 1). Univents draw air from outdoors through a fresh air intake located on the exterior walls of the building (see Picture 2) and return air through an air intake located at the base of each unit ([see Figure 1](#)). Fresh air and return air are mixed, filtered, heated and provided to classrooms through a fresh air diffuser located in the top of the unit. Univents were found deactivated in a number of classrooms (see Tables/Picture 3). Obstructions to airflow, such as books, papers, and desks were seen in a number of classrooms (see Picture 4). In order for univents to provide fresh air as designed, they must be unblocked and remain free of obstructions. Importantly, these units must be activated and allowed to operate.

**Unit Ventilator (Univent)**

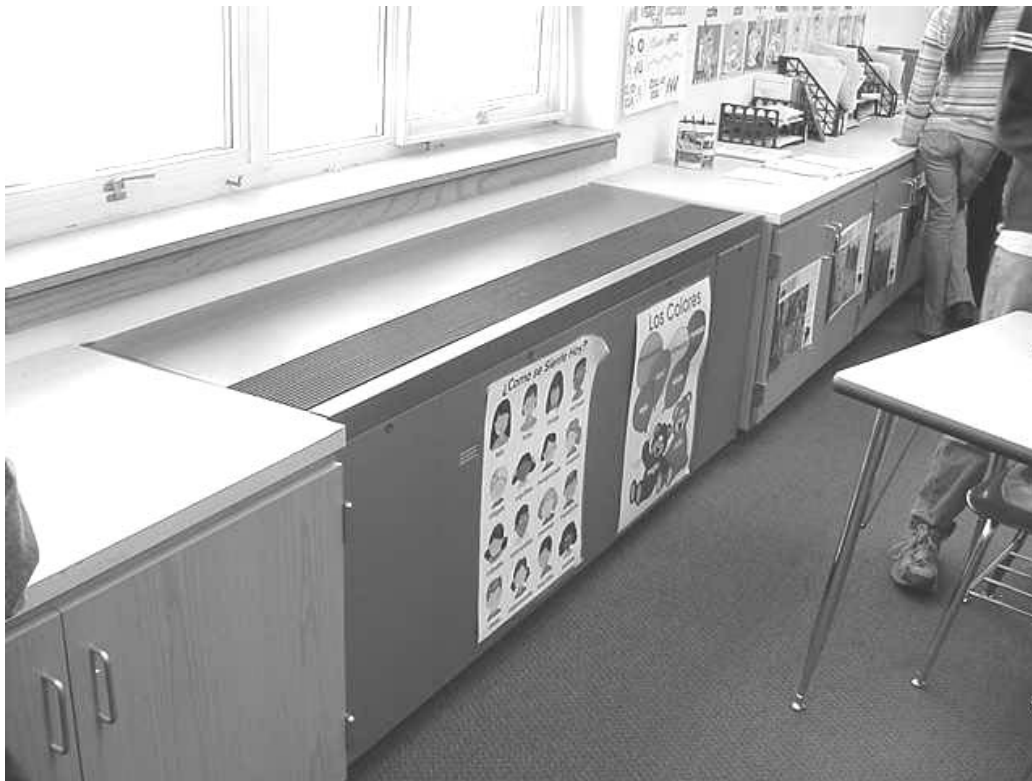
**Picture 1**

**Classroom Univent**

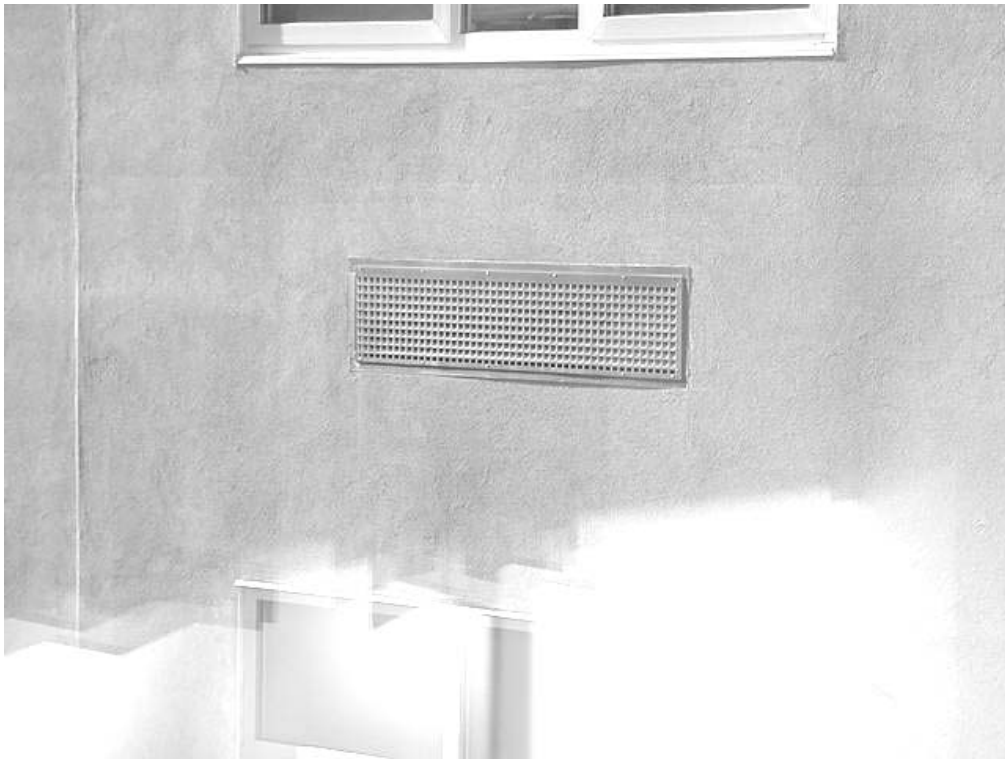
**Picture 2**

**Univent Fresh Air Intake on Exterior of Building**

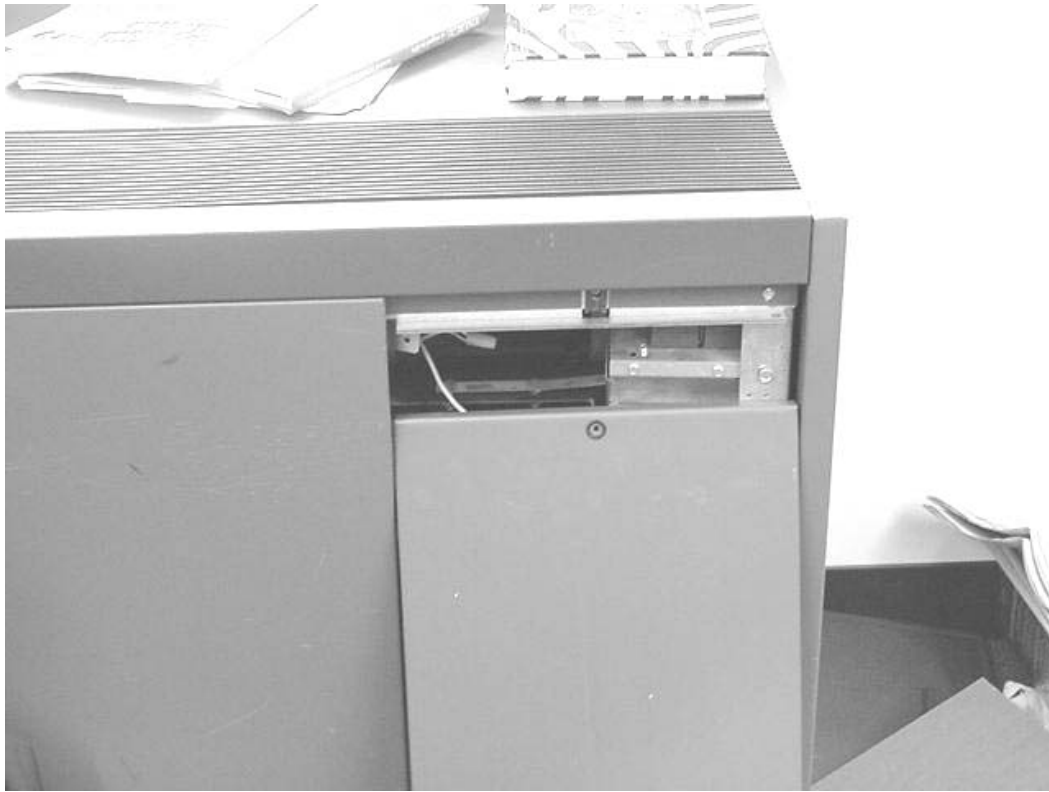
**Picture 3**

**Deactivated Classroom Univent, Note Access Panel Removed**

1. Re-seal observation holes in GW in classrooms. Inspect areas previously impacted by water penetration (e.g., exterior caulking, interior GW) periodically to ensure building envelope is maintained.
2. Operate mechanical ventilation during periods of school occupancy to maximize air exchange. School staff should be encouraged not to deactivate classroom univents.
3. Examine rooftop exhaust motors for proper function. Repair/replace belts and parts as necessary.
4. Remove all obstructions from univents and mechanical exhaust vents to facilitate airflow.
5. Faculty and staff are encouraged to report any complaints concerning temperature control/preventive maintenance issues to the facilities department in the form of a

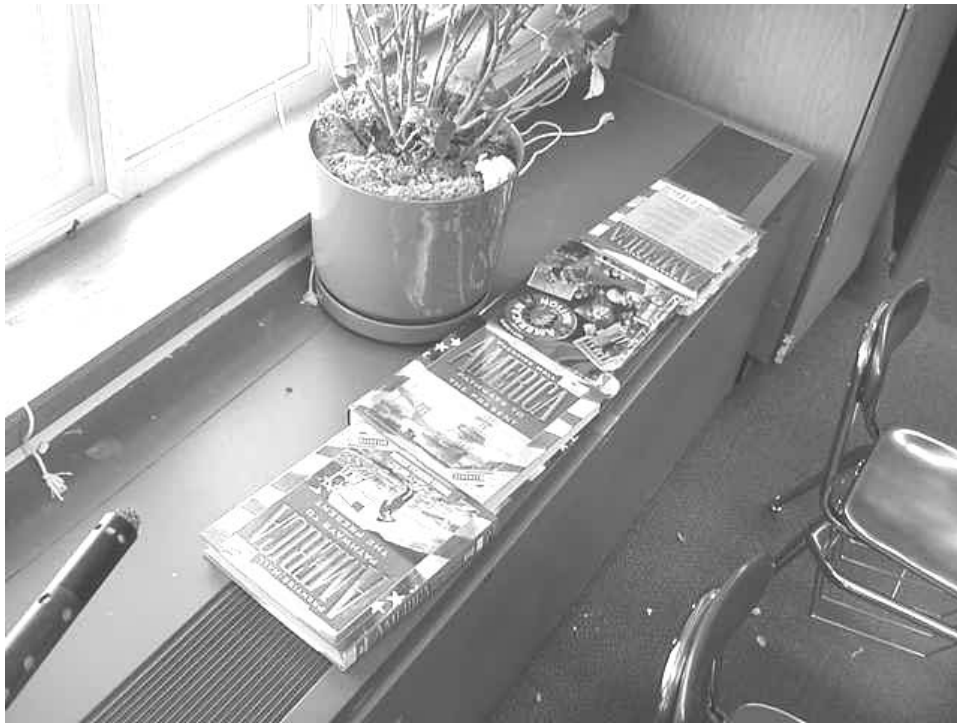
**Picture 4**

**Books on Univent Air Diffuser Obstructing Airflow, Also Note Plant on Univent**

9. Ensure plants are equipped with drip pans. Examine drip pans periodically for mold growth and disinfect with an appropriate antimicrobial where necessary. Move plants away from air diffusers in classrooms.

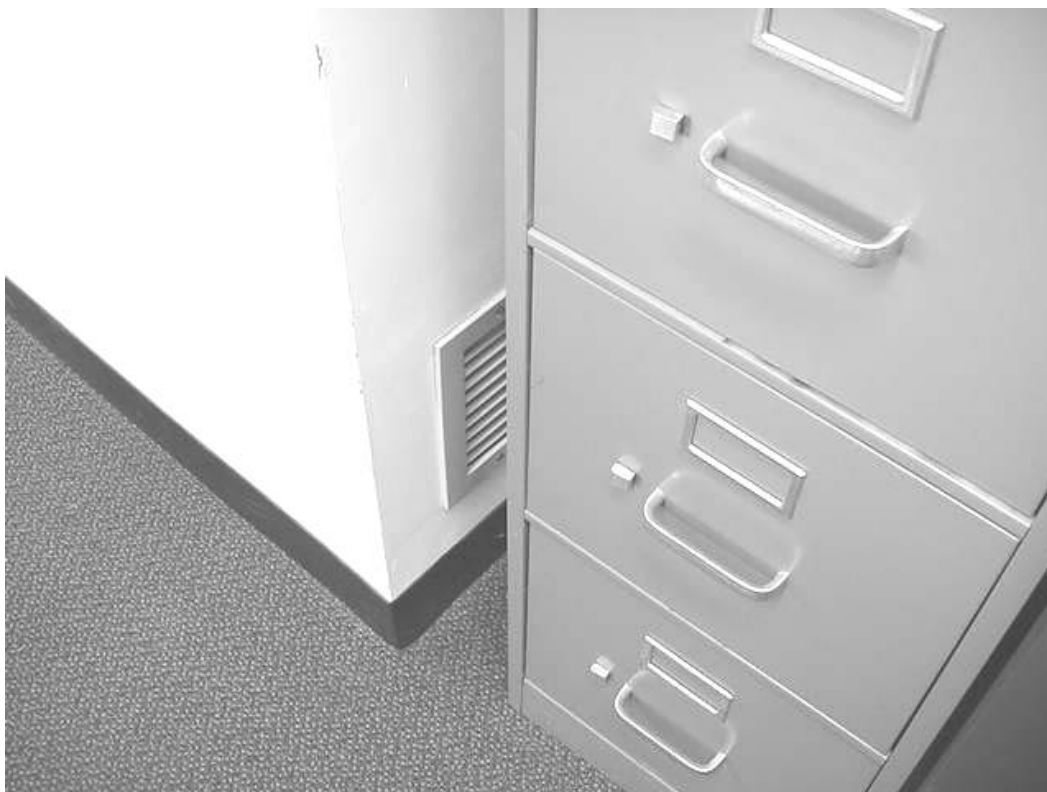
**Picture 5**

The mechanical exhaust ventilation system consists of ceiling and wall-mounted exhaust vents. Little or no draw of air was detected in several classrooms (see Tables), which can indicate that either the exhaust ventilation was turned off, or that rooftop motors were not functioning. A number of exhaust vents were obstructed by tables, chairs, boxes and other items (see Picture 5). The location of some exhaust vents can also limit exhaust efficiency when the classroom hallway door is open (see Picture 6). When a classroom door is open, exhaust vents will tend to draw air from both the hallway and the classroom. The open hallway door reduces the effectiveness of the exhaust vent to remove common environmental pollutants from classrooms. Without removal by

**Classroom Exhaust Vent Obstructed by File Cabinet**

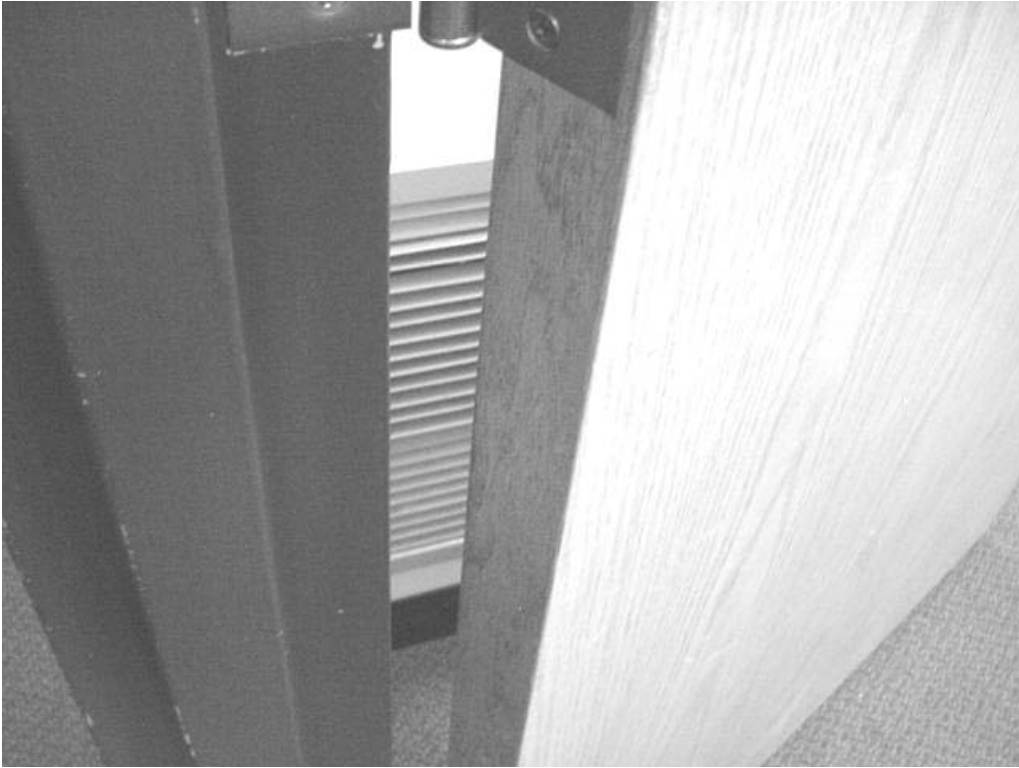
**Picture 6**

**Wall-Mounted Classroom Exhaust Vent Behind Open Door**

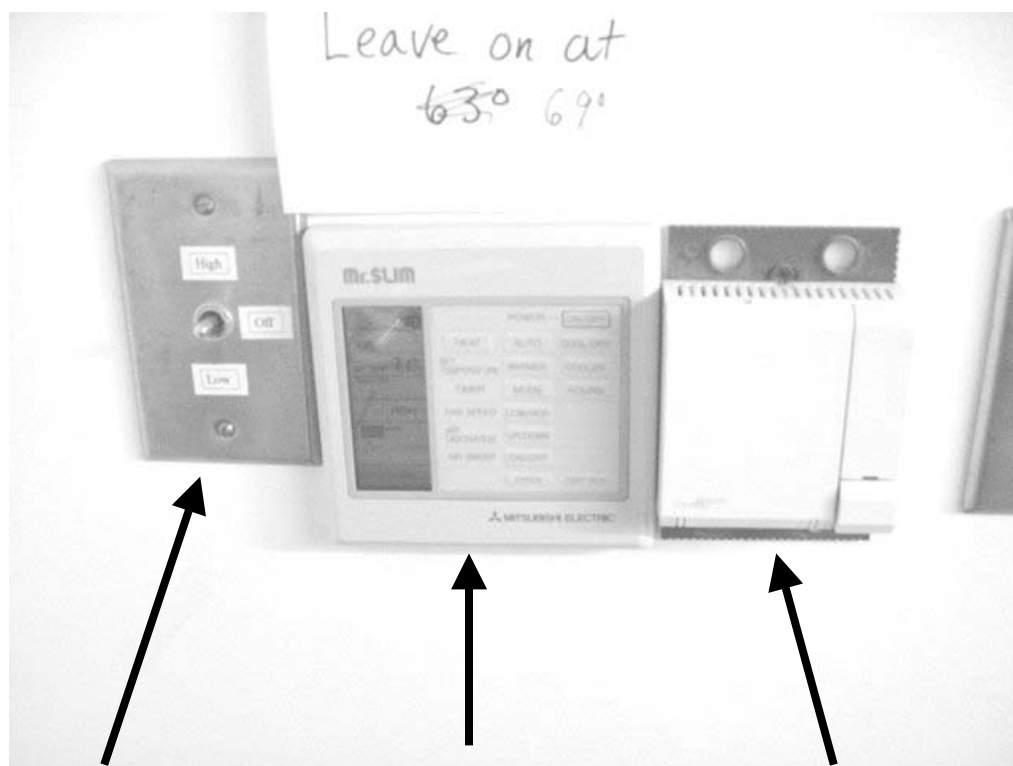
**Picture 7**

Science classrooms are equipped with three separate ventilation controls (see Picture 7). One control activates an air conditioning system during warm weather months; a second control, similar to other classrooms, controls the unit ventilator; and a third control activates an additional exhaust vent installed to facilitate ventilation during science experiments.

**exhaust fan**

**AC system**

**classroom thermostat/univent control**

**Ventilation Controls for Science Room/Lab**

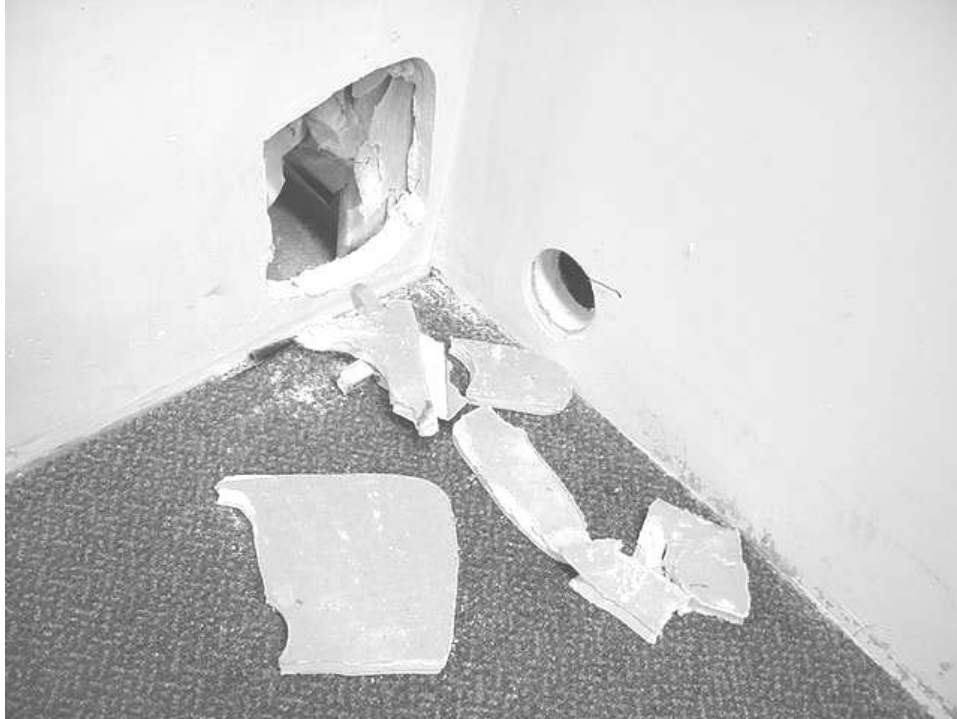
**Picture 8**

The BEHA assessment occurred after several days of intermittent rain. At the time of the BEHA assessment, no elevated moisture readings were measured; nor was standing water or visible mold growth observed in the wall cavity (see Picture 8). As stated previously, the source of water penetration was reportedly eliminated by re-caulking exterior wall junctions; all water damaged building materials were removed and replaced; and all non-porous areas effected by water penetration were dried out and disinfected.

**Sections of GW Removed to Observe Conditions in Wall Cavity**

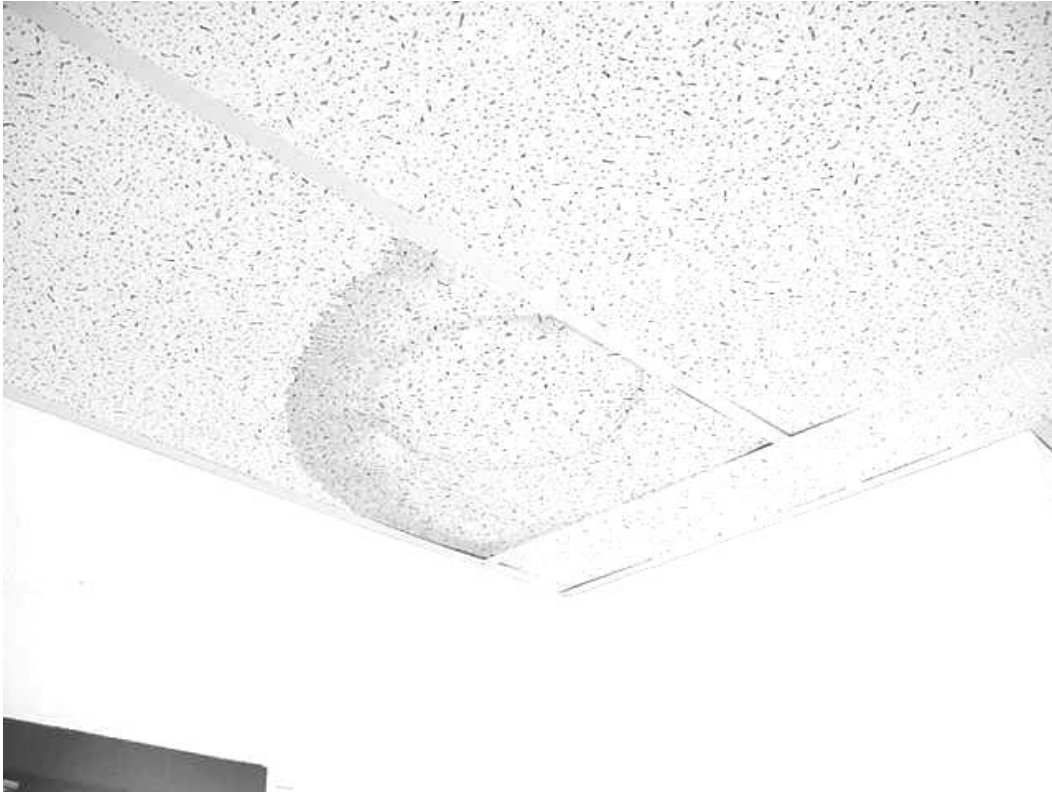
**Picture 9**

A number of rooms had water-stained ceilings and ceiling tiles, which are evidence of roof and/or plumbing leaks (see Picture 9). Water-damaged ceiling tiles can provide a source of mold and mildew growth and should be replaced after a leak is discovered.

**Water-Damaged Ceiling Tile**

8. Repair any existing water leaks and replace any remaining water-stained ceiling tiles. Examine the areas above these tiles for mold growth. Disinfect areas of water leaks with an appropriate antimicrobial as needed.

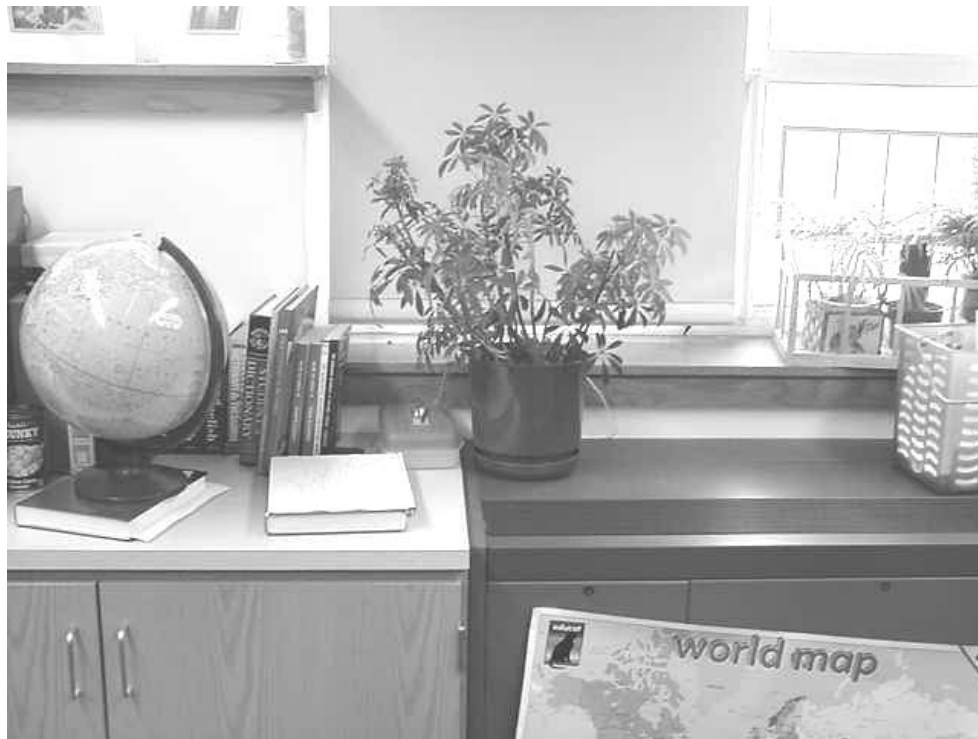
**Picture 10**

Plants were noted in several classrooms. Plants can be a source of pollen and mold, which can be respiratory irritants to some individuals. Plants should be properly maintained and equipped with drip pans. Plants should also be located away from air diffusers to prevent aerosolization of dirt, pollen or mold (see Picture 10 & 11). In hallways, water fountains were observed mounted over carpeted floors (see Picture 12). Leakage or overflow can cause water damage to carpeting and potentially lead to microbial growth. The American Conference of Governmental Industrial Hygienists (ACGIH) recommends that carpeting be dried with fans and heating within 24 hours of becoming wet (ACGIH, 1989). If carpets are not dried within this time frame, mold growth may occur. Once mold has colonized porous materials, they are difficult to clean and should be removed.

**Plants on Classroom Univent**

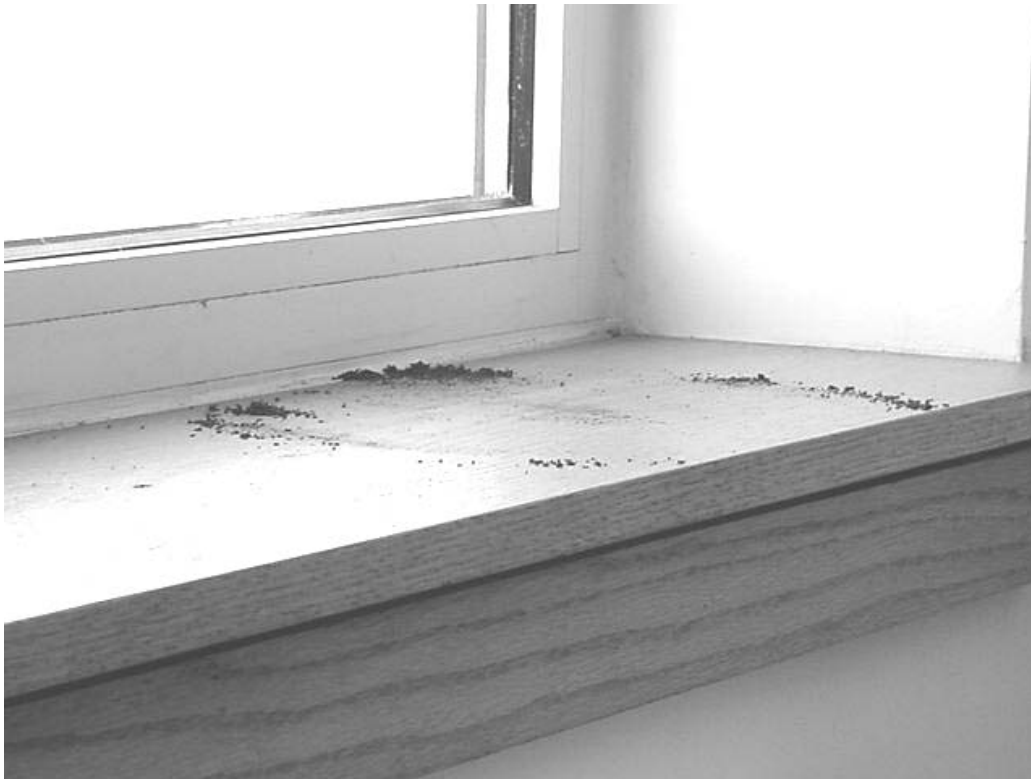
**Picture 11**

**Potting Soil on Windowsill near Classroom Univent**

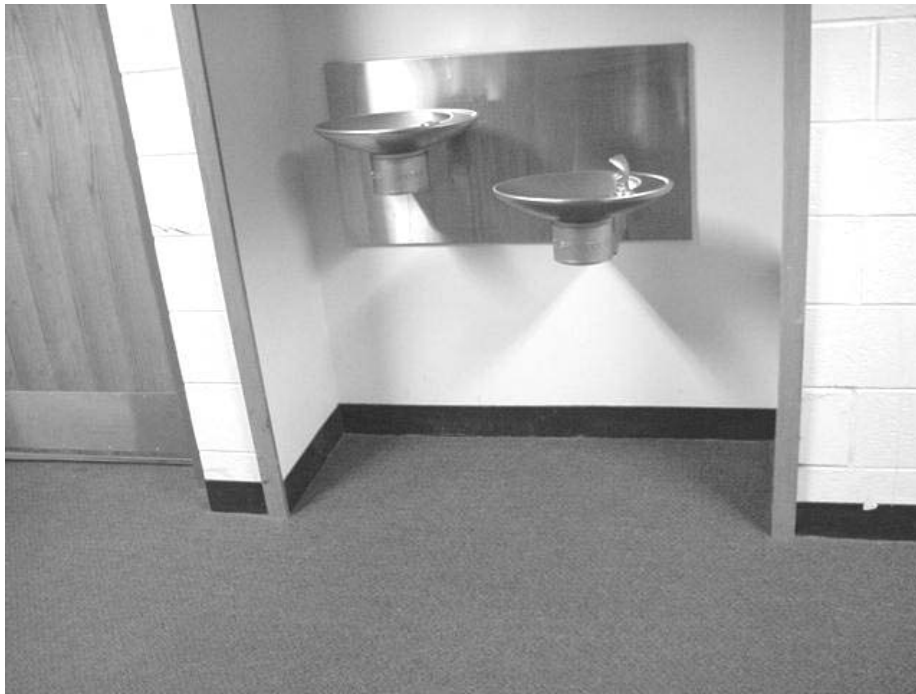
**Picture 12**

**Water Fountains Installed over Carpeting in Main Hallways**

10. Place tile or rubber matting underneath water coolers/fountains in carpeted areas.
11. Clean and maintain aquariums and animal cages to prevent bacterial/mold growth and/or odors.
